Bureau of Watershed Assessment and Research
Division of Water
NYS Department of Environmental Conservation

The 2002 Niagara River/Lake Erie Basin Waterbody Inventory and Priority Waterbodies List

Encompassing all or portions of
Allegany, Cattaraugus, Chautauqua,
Erie, Genesee, Niagara,
Orleans and Wyoming Counties

July 2003

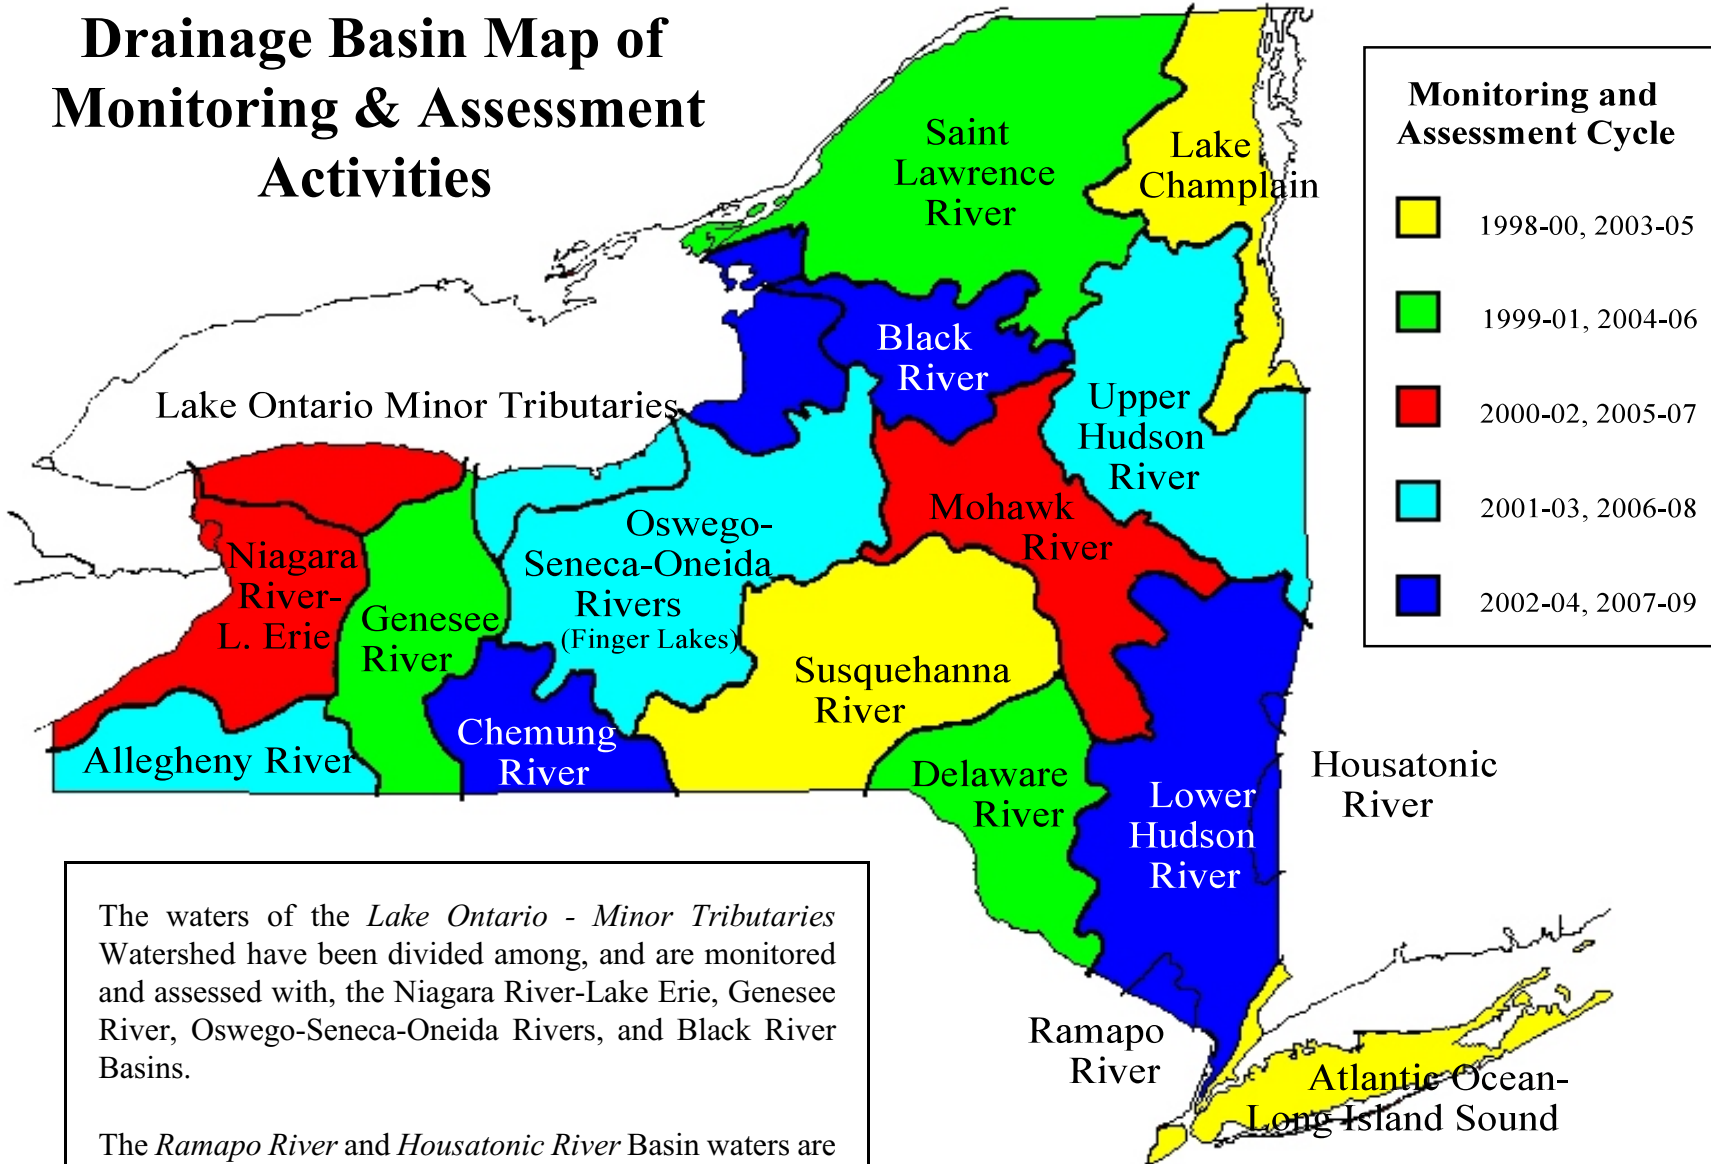
Drainage Basin Map of Monitoring & Assessment Activities

The waters of the *Lake Ontario - Minor Tributaries* Watershed have been divided among, and are monitored and assessed with, the Niagara River-Lake Erie, Genesee River, Oswego-Seneca-Oneida Rivers, and Black River Basins.

The *Ramapo River* and *Housatonic River* Basin waters are included in the Lower Hudson River Report.

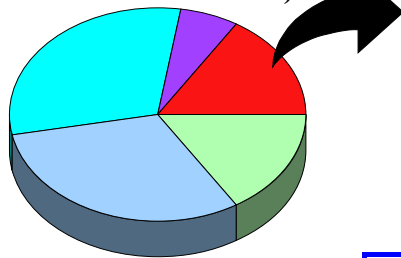
Water Quality Assessment Categories
(for ALL Water in the Basin)

- PWL - Not Supporting Uses
- PWL - Other Minor Impacts
- No Known Impacts
- UnAssessed Waters
- Impacts Needing Verification

Total River Miles: 5389
Total PWL Miles: 1216

About one-fourth of the river miles in the Niagara River/Lake Erie Basin (1,216 miles) are listed on the Priority Waterbodies List as either not supporting uses or having minor impacts or threats to water quality. About one-fourth of these miles are considered *Stressed* or *Threatened* waters that fully support appropriate uses, but with minor impacts/threats. About sixteen percent of basin river miles are *Impaired* and do not support appropriate uses.

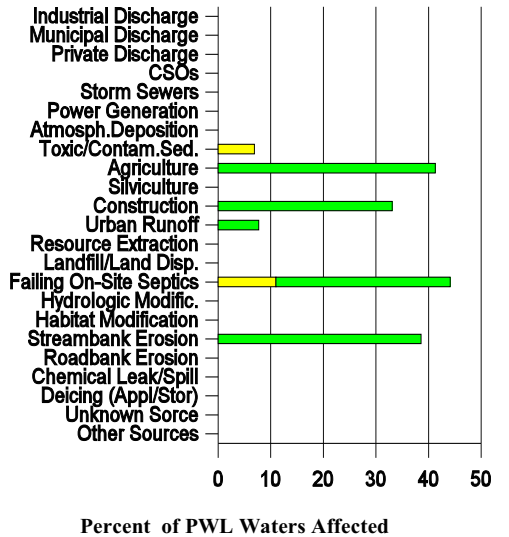
Major Sources - Priority Waterbodies

Niagara/Lk. Erie Basin
 Total Lake Acres: 1098
 Total PWL Acres: 465

There are seven lakes (about 42% of the total acreage in the basin) included on the PWL. Impacts to Delaware Park Pond (fish consumption) and Java Lake (recreational use) account for all the impaired lakes/reservoirs in the basin. Agriculture, contaminated sediments and failing on-site septic systems are the suspected sources for

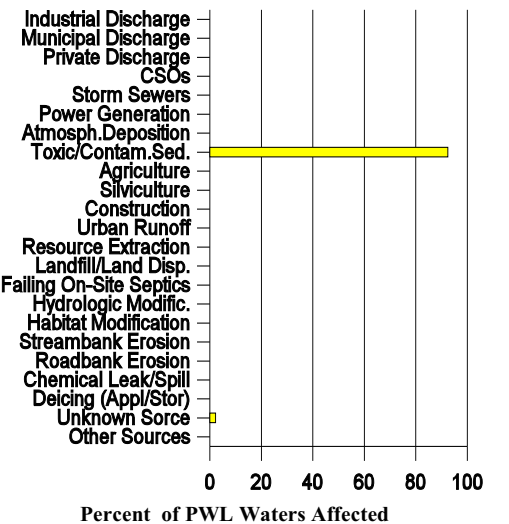
Major Sources - Priority Waterbodies

Niagara/Lk. Erie Basin
 Total Shore Miles: 92
 Total PWL Miles: 92

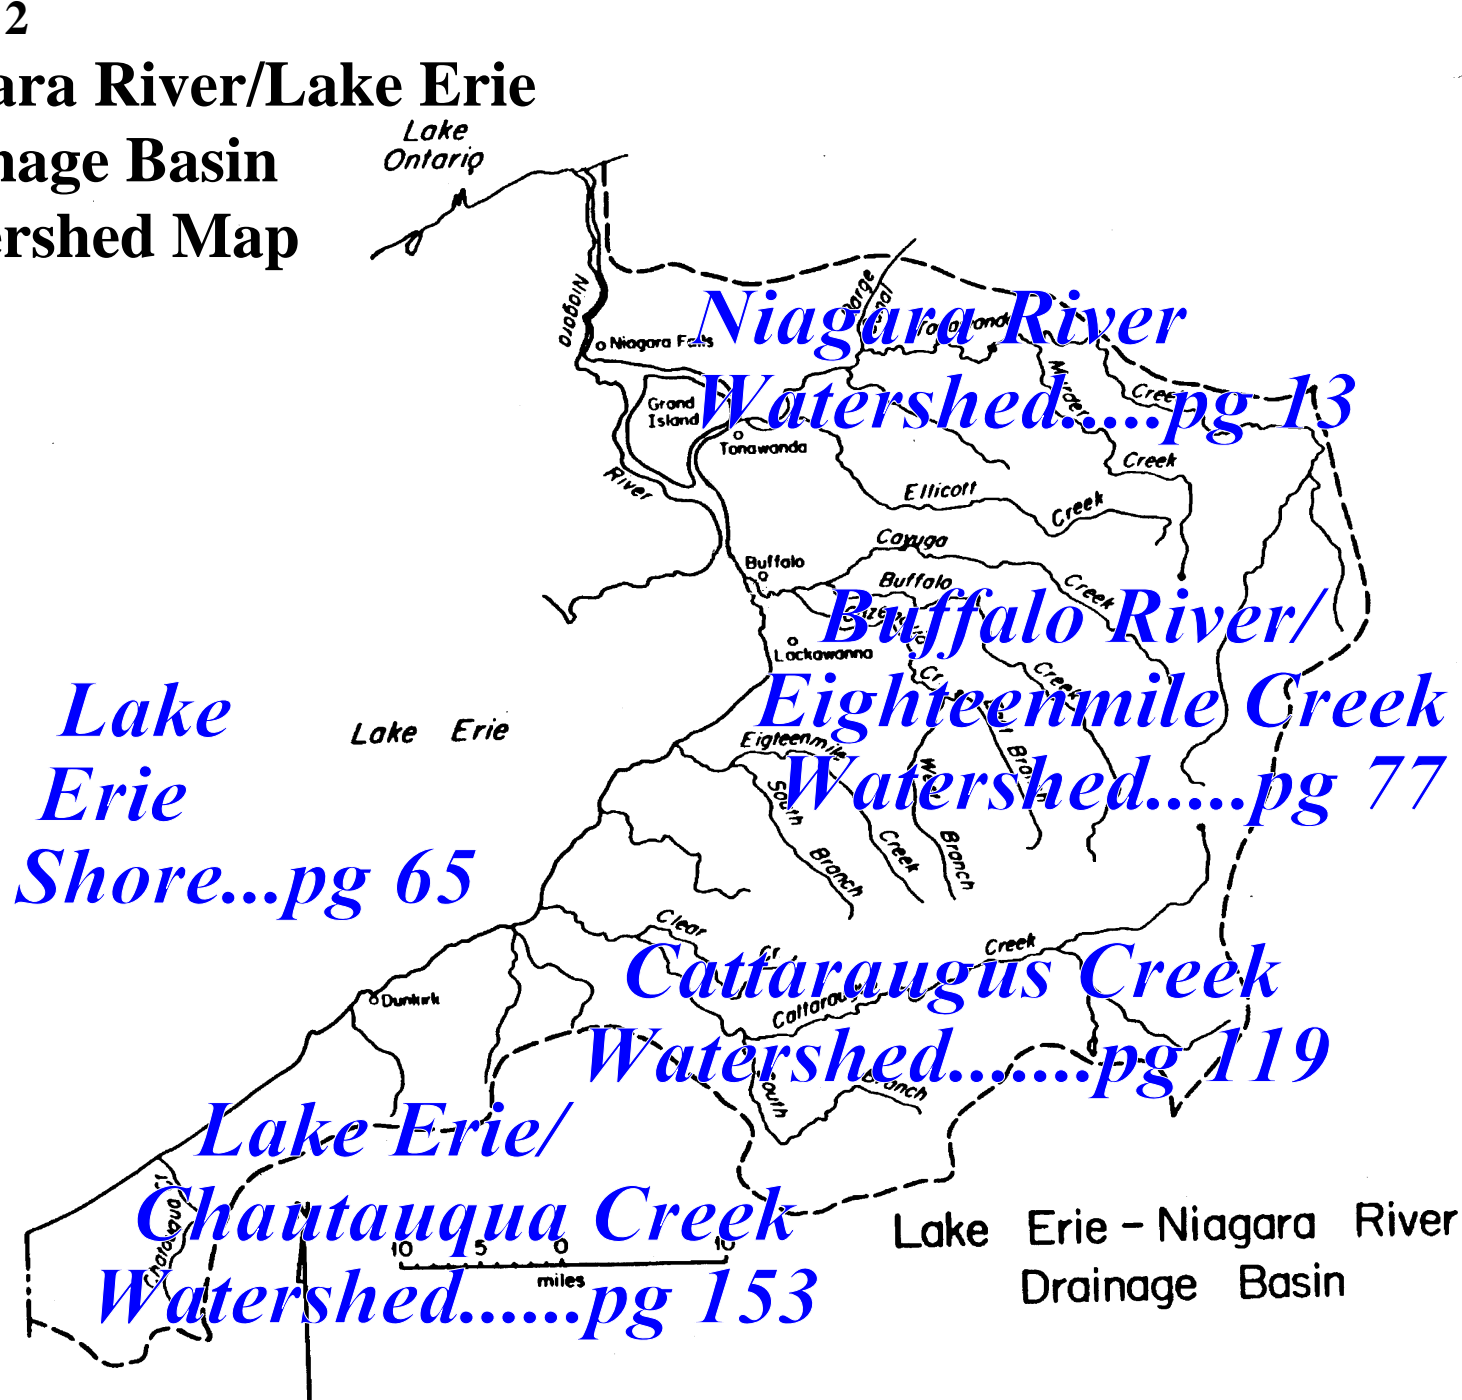
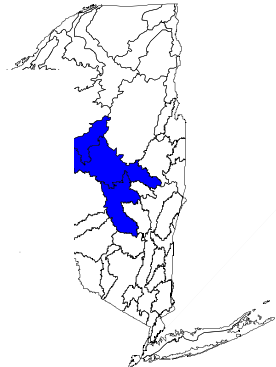
Figure 2

**Niagara River/Lake Erie
Drainage Basin
Watershed Map**

The data sheets on the following pages are compiled in hydrological order and grouped by US Geological Survey Hydrologic Unit Code (HUC) basin and smaller watersheds in the Niagara River/Lake Erie Basin (see Figure 2). An outline of the specific waterbodies in each watershed is presented at the beginning of each Watershed Section. Data sheets are included for each waterbody that has been assessed; that is, waterbodies listed as *Impaired Segments*, *Segments with Minor Impacts*, *Threatened Waters*, waters with water quality impacts *Needing Verification*, or waterbodies with *No Known Impact*. *UnAssessed* waterbodies are listed in the hydrologic outline of waterbodies at the front of each Watershed Section; however, separate data sheets for these segments are not included.
