## Proposed Ecological Restoration Projects

### 4.1 Development of Conceptual Habitat Restoration Projects

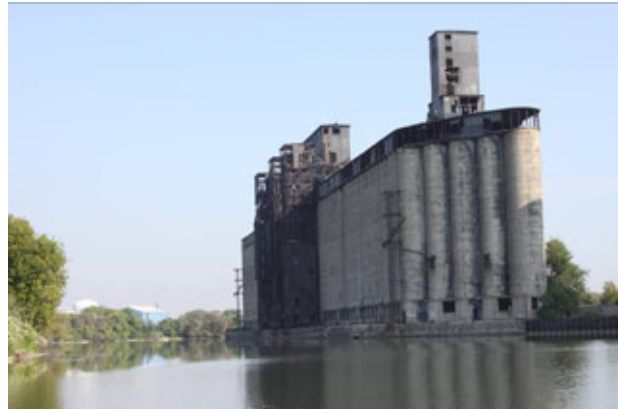
**Photo 4.1-1 Abandoned Grain Elevators and modified stream banks within navigation channel**

The landscape adjacent to the waterways within the ERMP focus area includes a mosaic of natural features, highly modified urban land, utility corridors, commercial and industrial facilities, urban infrastructure, parkland, agriculture, and private/residential lands (see Photo 4.1-1). Candidate project locations were assessed with respect to the current physical and ecological attributes and impairments in the context of their landscape position, adjacent land uses, and conditions upstream and downstream of each site.

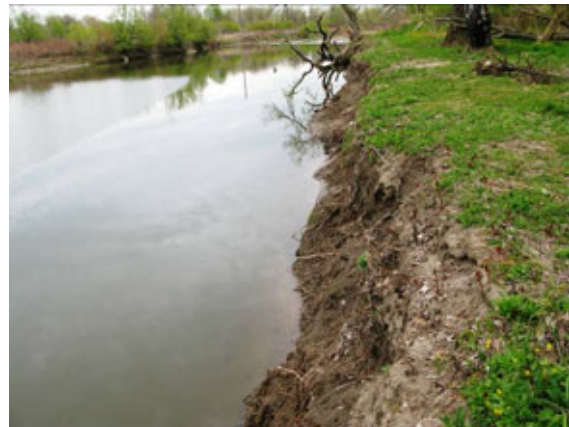
**Photo 4.1-3 Seneca Bluffs lower terrace bank failure with invasive plant understory (Japanese Knotweed and Lesser Celandine)**

Sites were assessed based on the severity of existing ecological impairments and the potential to improve ecological functions through restoration measures that address one or more BUIs. Conditions that stress the biological and physical elements of the sites (see Photo 4.1-3) were identified in the following critical habitat zones:

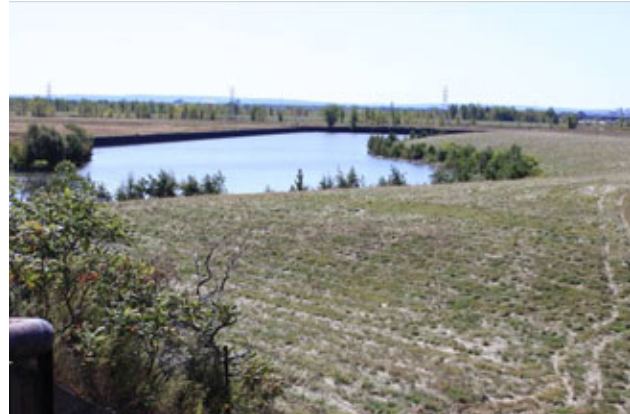
**Photo 4.1-4** Inland and upland area in Urban Brownfield, lower Buffalo River

- **Inland and Upland** – The area extending away from the stream channel and top of stream bank (see Photo 4.1-4); may contain floodplain, wetland, upland, or a combination of these habitats. Provides habitat for terrestrial and wetland species. Cover can be quite variable, including mature canopy tree cover, invasive species, fill and debris piles, active park land, etc. When well vegetated, can establish habitat connectivity between areas by providing wildlife movement corridors.

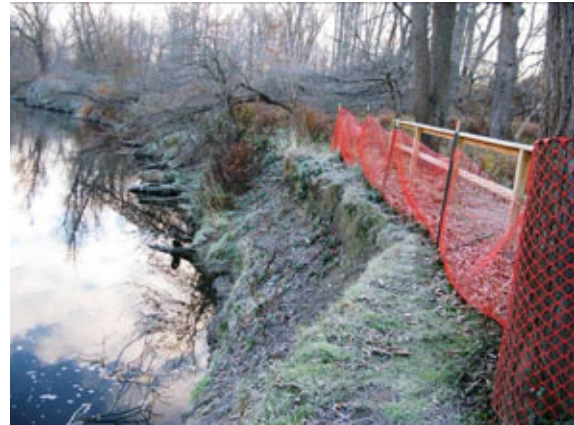
**Photo 4.1-5 Stiglmeier Park bank failure, sediment loading, and loss of riparian habitat**

The conceptual design features provided for each site presented in Section 4.2 have been selected to address observed impairments (e.g., stream bank failures - see Photo 4.1-5) within the affected habitat zones for the purpose of restoring and/or enhancing ecological function. Potential project stakeholders need to rec-

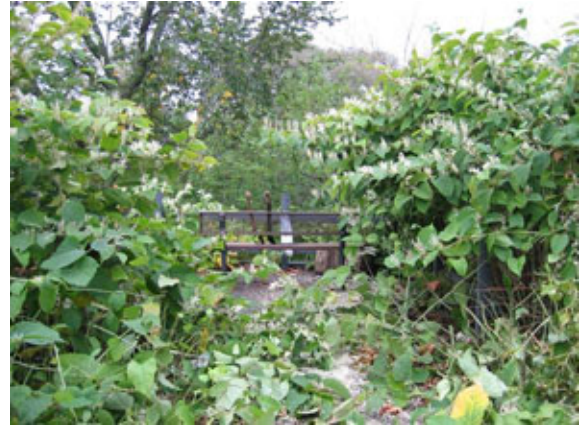
**Photo 4.1-6** Japanese knotweed-dominated riparian area and public access at Bailey Woods

Invasive species warrant special attention due to the threats they pose to ecological integrity and their role in exacerbating riverine and riparian impairments (see

Photo 4.1-6). The presence of invasive species is common to all sites and degrades riparian habitat by crowding out native species that contribute important habitat functions. Expanding areas of single or multiple invasive species negatively affect each site. Invasive species severely impair wildlife habitat on all sites, with substantial modifications in cover, structure, and available forage. They also can contribute to the physical degradation of the sites by shading out native species that better protect the soil and stream banks. The most prevalent invasive species observed include:

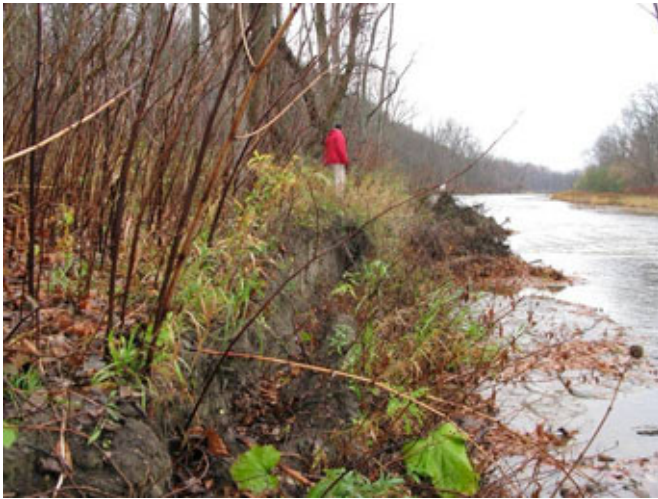
**Photo 4.1-7 Bank failure on West Seneca Developmental Center site along Cazenovia Creek with Japanese knotweed riparian understory**

A majority of the sites exhibit extensive stream bank erosion, which contributes to degraded water quality, and negative impacts on: fishery, benthic, and riparian habitats. Stream bank erosion and bank failures, and subsequent sediment loading, are directly linked to the prevalence of invasive plant communities. Invasive plant monocultures such as Japanese knotweed provide minimal soil stabilization and expose surface soils to erosion by eliminating native vegetation layers. Bank failures were evident on sites where invasive plant communities exist along stream banks and inland riparian areas (see Photo 4.1-7). Many inside channel bends, which are not normally susceptible to erosion from scouring flows, were failing due to unstable stream bank soils.
