4.3 Prioritizing the Selected Habitat Restoration Projects

4 Proposed Ecological Restoration Projects

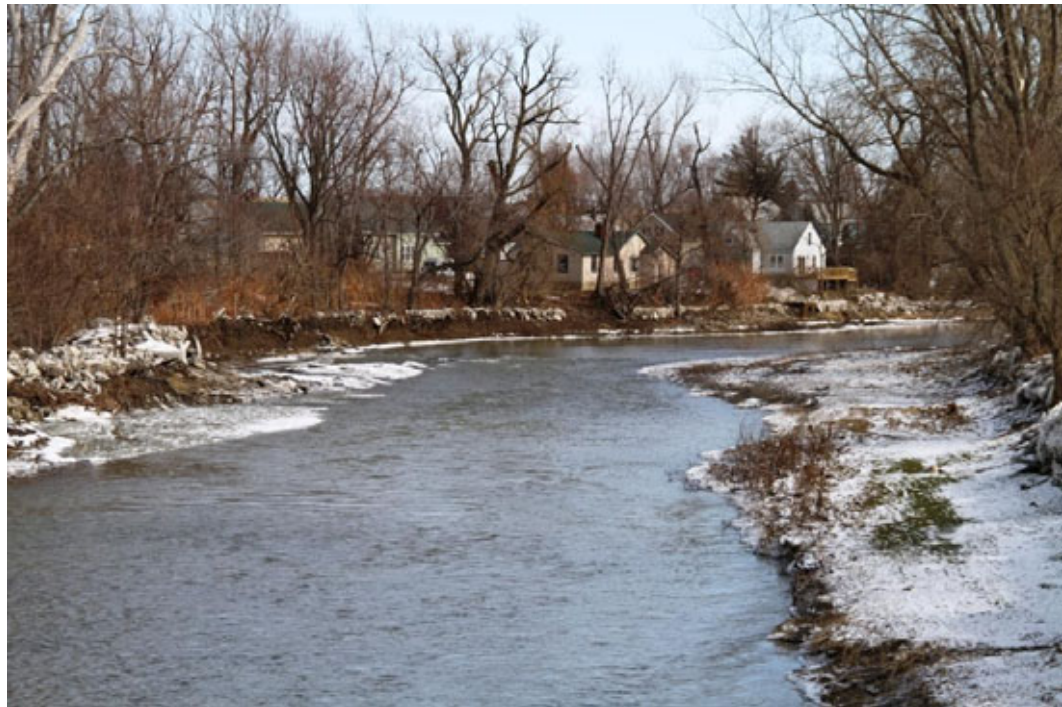
Photo 4.3-1 Cazenovia Park site continual bank failure, observed on February 21, 2011

The sites selected for development of ecological restoration projects exhibit significant, urgent problems that warrant consideration for action in the near future. Field observations conducted prior to 2010 and then later during ERMP field assessments have confirmed the occurrence of extensive stream bank instability, which has resulted in substantial loss of stream bank and riparian vegetation throughout the ERMP focus area. For example, after two combined flood stage and ice out events in early and late February 2011, field observations at some sites suggest that significant stream bank and floodplain soil losses have occurred since the ERMP field assessments were completed in the fall of 2010. Additionally, based on qualitative observations in March of 2011, Seneca Bluffs, Cazenovia Park, and Stiglmeier Park exhibited stream bank losses of approximately 3 to 5 feet from early November 2010 to March 2011 across hundreds of linear feet of stream bank (cumulatively). Land is being lost and the river/creek channels are becoming wider due to undercutting and subsequent collapse of soil and vegetation into the river/stream channel. Review of aerial imagery suggests that soil loss (and therefore riparian loss) on these sites has been accelerating.

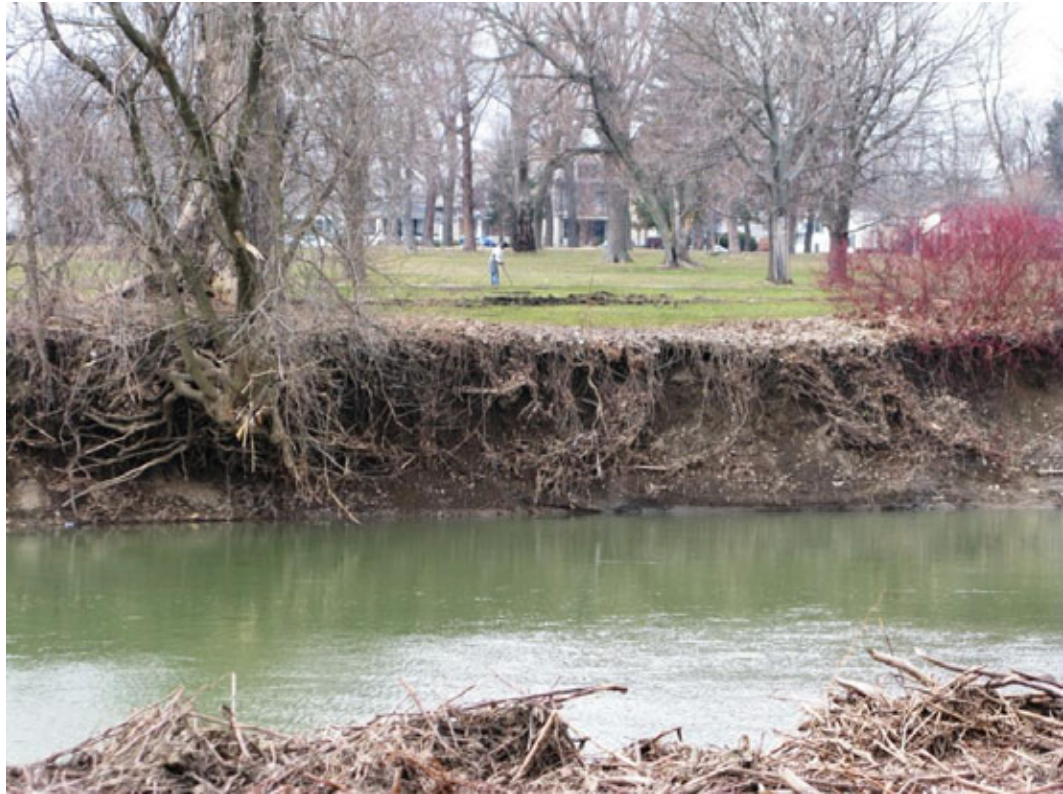
Photo 4.3-2 Cazenovia Park LDB undercutting and failure at Golf Course, observed on April 3, 2011

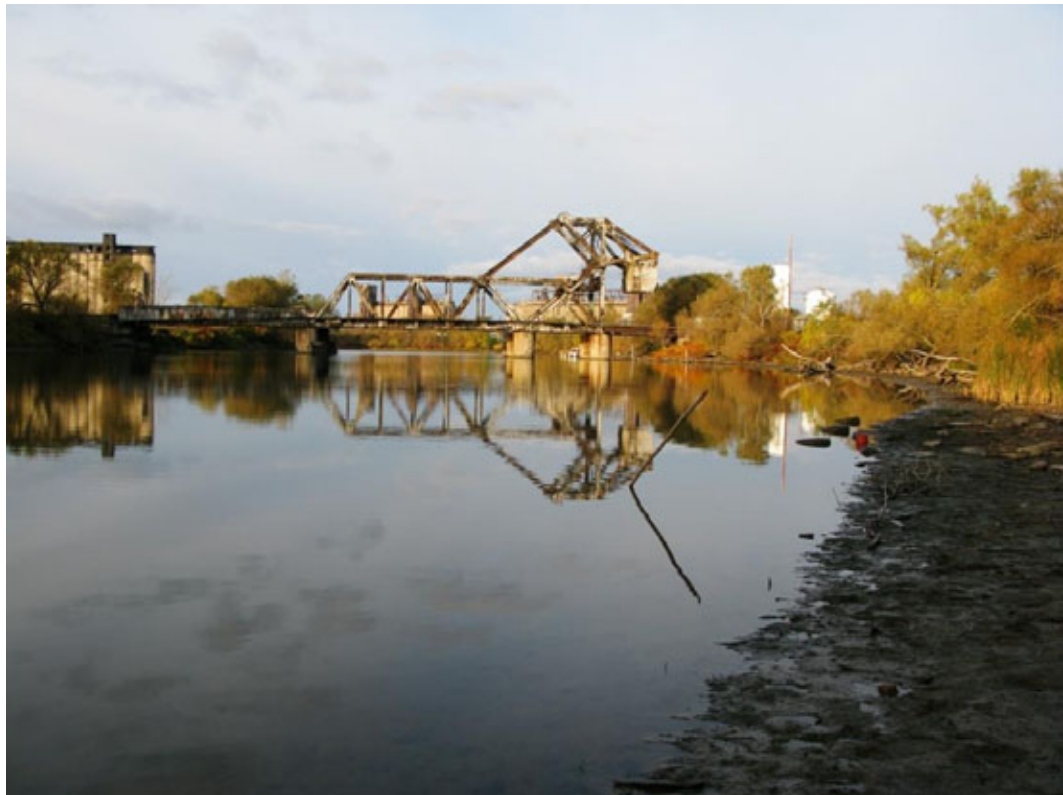
Photo 4.3-3 Remedial dredging along Smith Street Park shoreline

These four sites are also near the federal navigation channel limits and the vicinity of the Buffalo River Habitat Restoration Project. The work planned under this GLLA project includes removal of contaminated sediment by dredging followed by restoration of natural habitat and structural features to support regeneration of native plant communities. Dredging of the navigation channel will begin in 2011 with stream bank stabilization and restoration activities to follow.
